F32 Newsletter

The Journal of the Freedom 32 Sailing Yacht Vol. 2 No. 5 May/June 1988

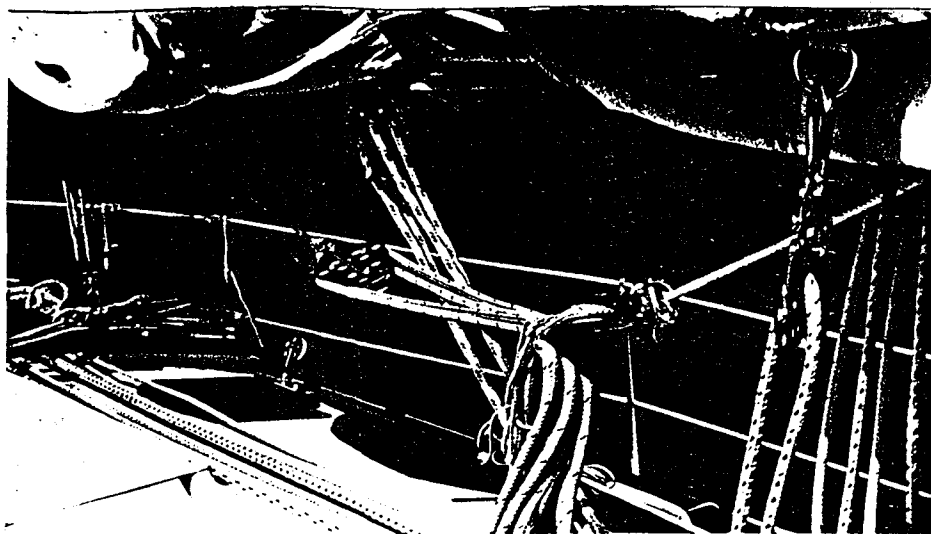
Mainsheet tackle- note sheet rubbing on cleat under boom. Genoa track and block by hand rail, drooping preventer tackle under boom. Reef hooks have been replaced by arrangement that can't fall out. Anyone know how to keep them from twisting?

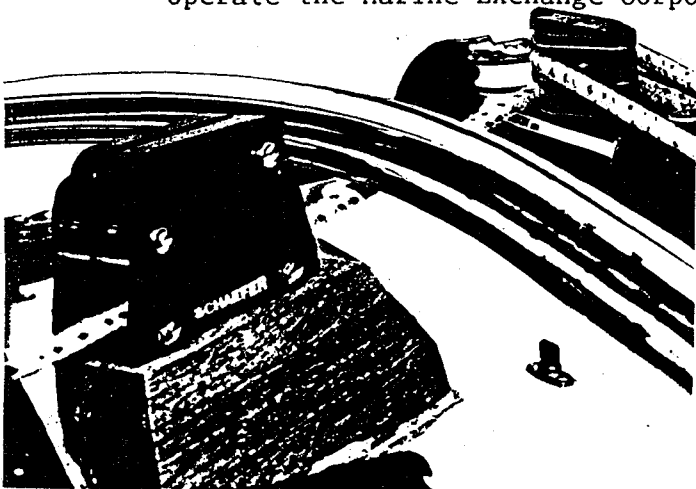
Port double gang clutch with teak mount. Mount plans are available. Note teak traveler end guard which prevents mainsheet hangups.
